Commercial and Consumer

Technical Report

TF200 Customer Complaint

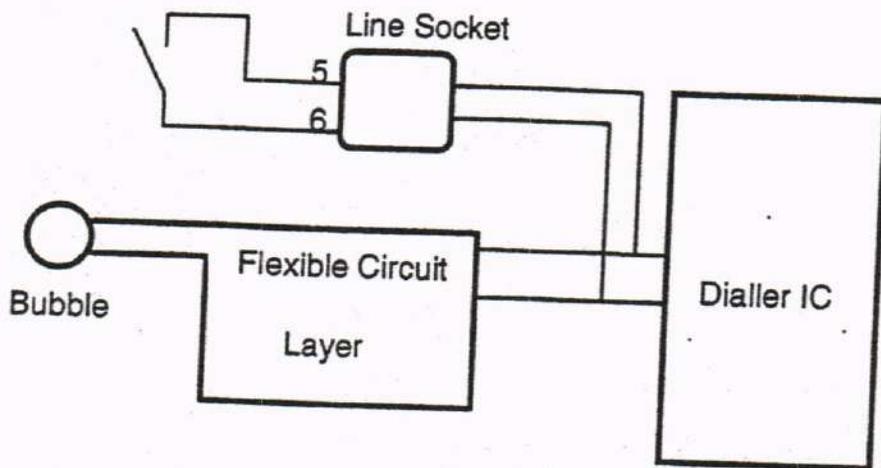
Figure 1. Hookswitch configuration in the TF200

The TF200 can be made to go off-hook either by lifting the handset or by connecting pins 5&6 at the line-cord socket. This facility was provided to allow expansion modules to be fitted to the TF200. If the phone is taken off-hook by connecting these two pins, the hookswitch part of the flexible circuit layer is not used. (figure 1)

The phone under investigation was taken on and off-hook repeatedly by connecting pins 5&6 and operated normally without any delay in returning to its on-hook state. This strongly suggested that the problem was related to the operation of the flexible circuit layer.

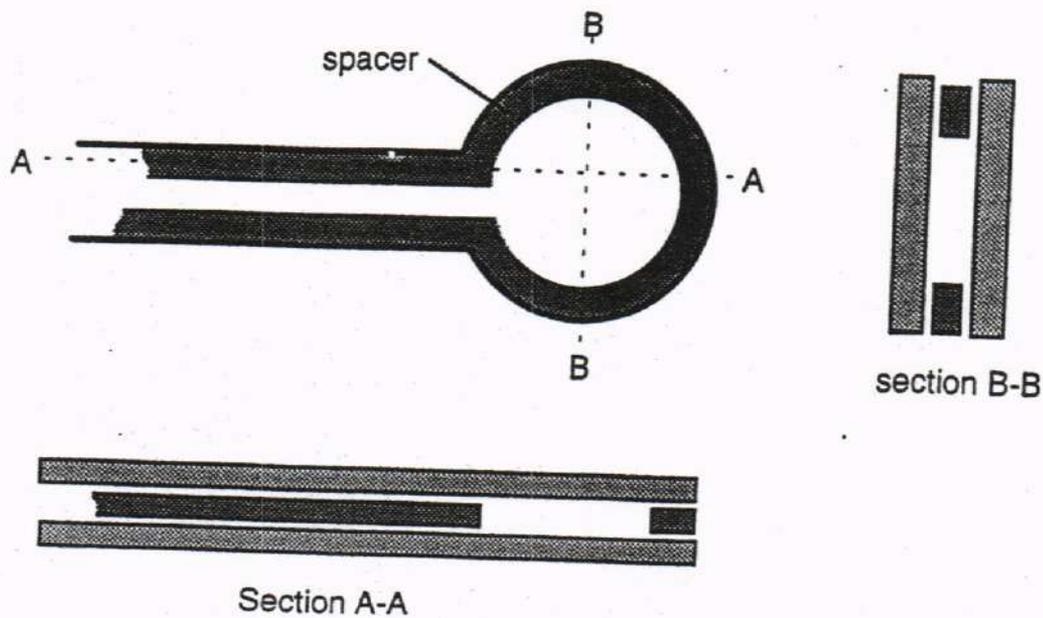
Figure 2. Diagram of hookswitch Bubble construction

It was thought that some of the sticky residue may have somehow entered the "bubble" that forms the hookswitch causing the two surfaces to stick together for a short time after the pressure is released. The "bubble" is formed by glueing two sheets of plastic together with a spacer in between. For reliable operation the seal around the bubble needs to be air-tight and thus, unless defective, could not allow the entry of any liquid.

The glue seal on the flexible circuit layer from the phone under investigation was visually inspected appeared to be satisfactory. (figure 2) The sticky residue is brown in colour and no discolouration is evident in the area of clear plastic around the outer perimeter of the bubble. This suggests that no liquid has managed to enter the bubble.

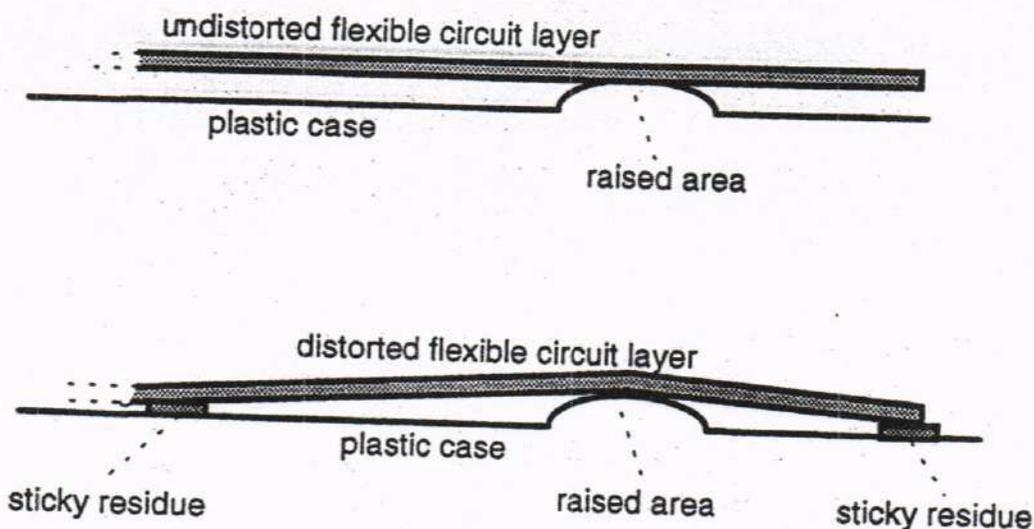
Figure 3. Flexible Circuit Layer in undistorted and distorted shape when stuck to the case.

The sticky residue in combination with the extra raised area in the plastic case has caused the problem of delayed return to on-hook conditions. The sticky residue is found either side of the raised area and when the phone is taken off-hook the flexible circuit layer is pressed against this sticky surface. **It is thought that after the handset is replaced and the pressure is removed the circuit layer remains stuck to the plastic case. Because the surface is not flat the flexible circuit layer is distorted sufficiently to cause the switch function in the bubble to operate.** Sometime after the handset is replaced (about 15 seconds) a part of the flexible circuit layer becomes unstuck and it returns to its undistorted shape. The hookswitch then operates normally, returns to a very high resistance and the phone goes into an on-hook condition. (figure 3)

The cause of the fault condition has been confirmed by Telecom Research to be due to the presence of a foreign substance possibly beer inside the telephone case which directly caused the incorrect operation of the telephone membrane hookswitch. When the hookswitch was removed from the foreign substance, the telephone operated correctly.

It is important that suitable guidelines be issued to field staff attending fault reports on rented telephones to note the conditions under which the Telecom property has been installed. It is the customer responsibility to look after the telephone and ensure that it is kept in a safe environment. It is Telecom's responsibility to ensure the telephone is installed in a safe location.
