Commercial and Consumer

**Technical Report**

**TF200 Customer Complaint**

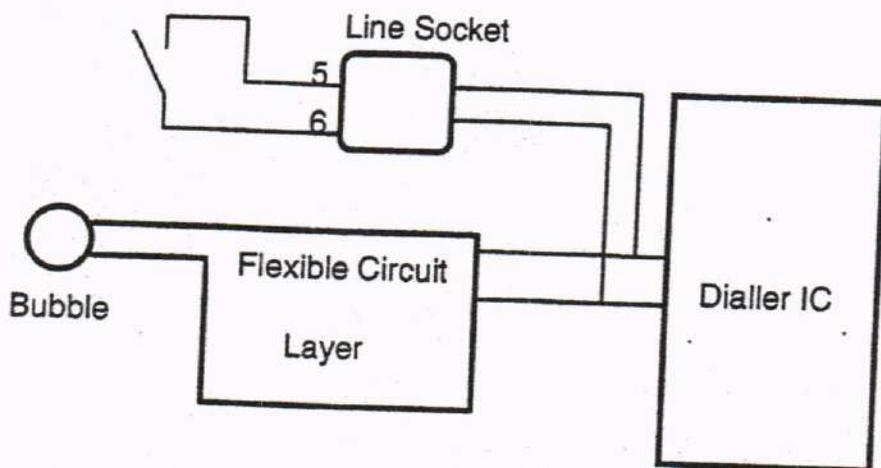
**Figure 1. Hookswitch configuration in the TF200**

The TF200 can be made to go off-hook either by lifting the handset or by connecting pins 5&6 at the line-cord socket. This facility was provided to allow expansion modules to be fitted to the TF200. If the phone is taken off-hook by connecting these two pins, the hookswitch part of the flexible circuit layer is not used. (figure 1)

The phone under investigation was taken on and off-hook repeatedly by connecting pins 5&6 and operated normally without any delay in returning to its on-hook state. This strongly suggested that the problem was related to the operation of the flexible circuit layer.

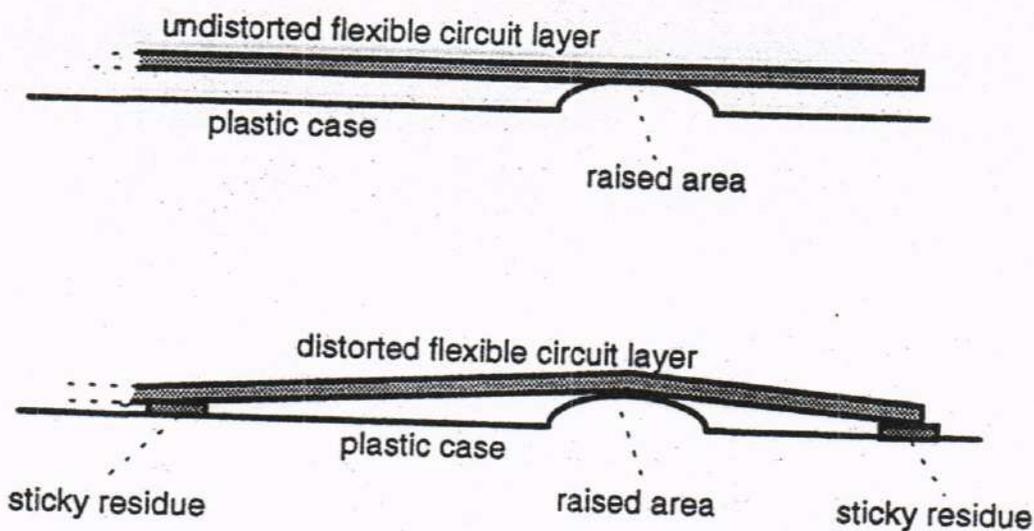
Figure 3. Flexible Circuit Layer in undistorted and distorted shape when stuck to the case.

The sticky residue in combination with the extra raised area in the plastic case has caused the problem of delayed return to on-hook conditions. The sticky residue is found either side of the raised area and when the phone is taken off-hook the flexible circuit layer is pressed against this sticky surface. **It is thought that after the handset is replaced and the pressure is removed the circuit layer remains stuck to the plastic case. Because the surface is not flat the flexible circuit layer is distorted sufficiently to cause the switch function in the bubble to operate.** Sometime after the handset is replaced (about 15 seconds) a part of the flexible circuit layer becomes unstuck and it returns to its undistorted shape. The hookswitch then operates normally, returns to a very high resistance and the phone goes into an on-hook condition. (figure 3)

The cause of the fault condition has been confirmed by Telecom Research to be due to the presence of a foreign substance possibly beer inside the telephone case which directly caused the incorrect operation of the telephone membrane hookswitch. When the hookswitch was removed from the foreign substance, the telephone operated correctly.
