Perversion of the Course of Justice

On the 28 November 1995, six months after my arbitration, I received evidence confirming that the Government owned carrier (the defendants in my arbitration) had actually carried out two separate investigations of my EXICOM TF200 touch-phone, two weeks apart, and that the second test report dated between 24 and 26 May 1994, proved that the first one, which had been provided to the arbitrator, was not a true account of the testing process at all but was a total fabrication. Photos and graphs (see Exhibit AS 1 and 2 attached below) show laboratory staff proved that, when wet beer was introduced into a TF200 phone it dried out completely in forty-eight hours. My phone, however, was collected from my business on 27 April 1994 and not tested until 10 May – a gap of fourteen days.

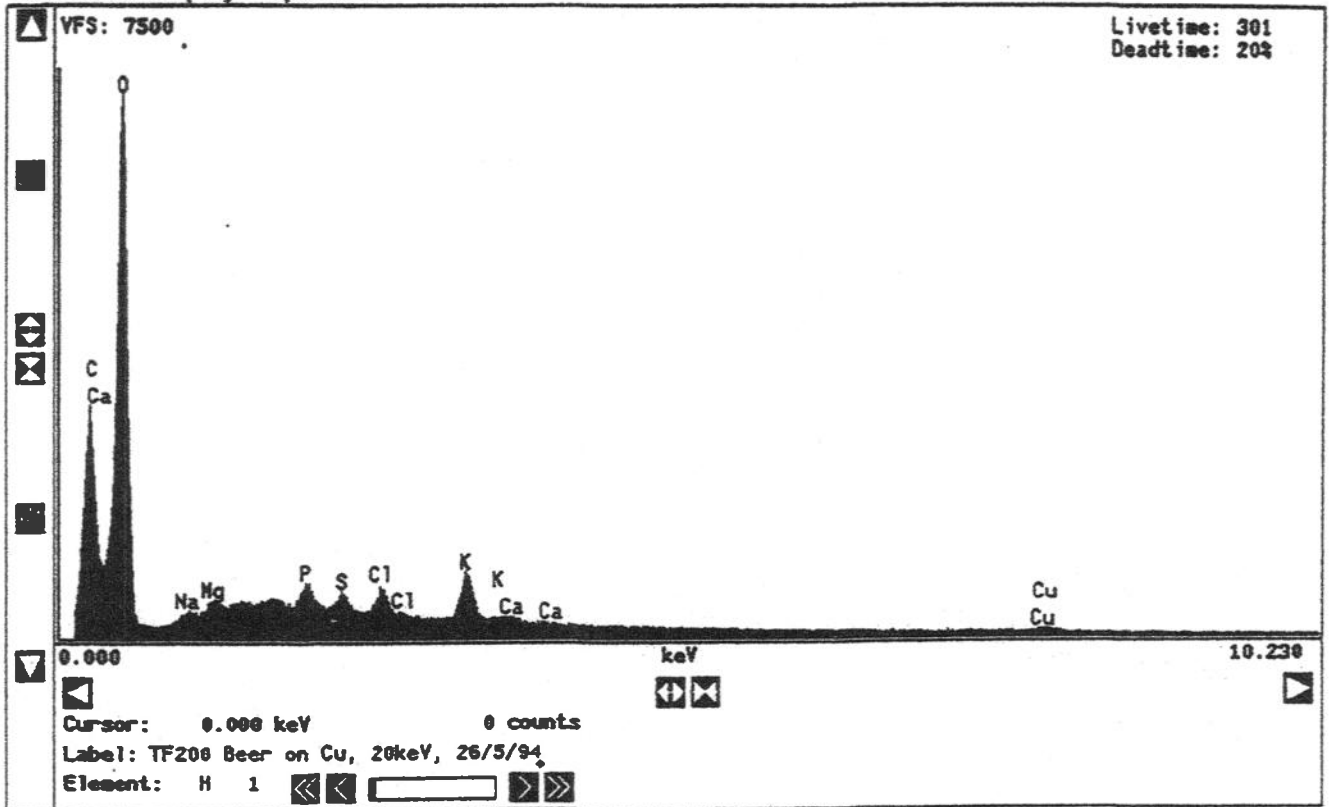
Exhibit AS 2

copy from original
Laboratory notebook
of Doug Kuhn
24/5/95

UTM-MicroZ Display - Spectrum7

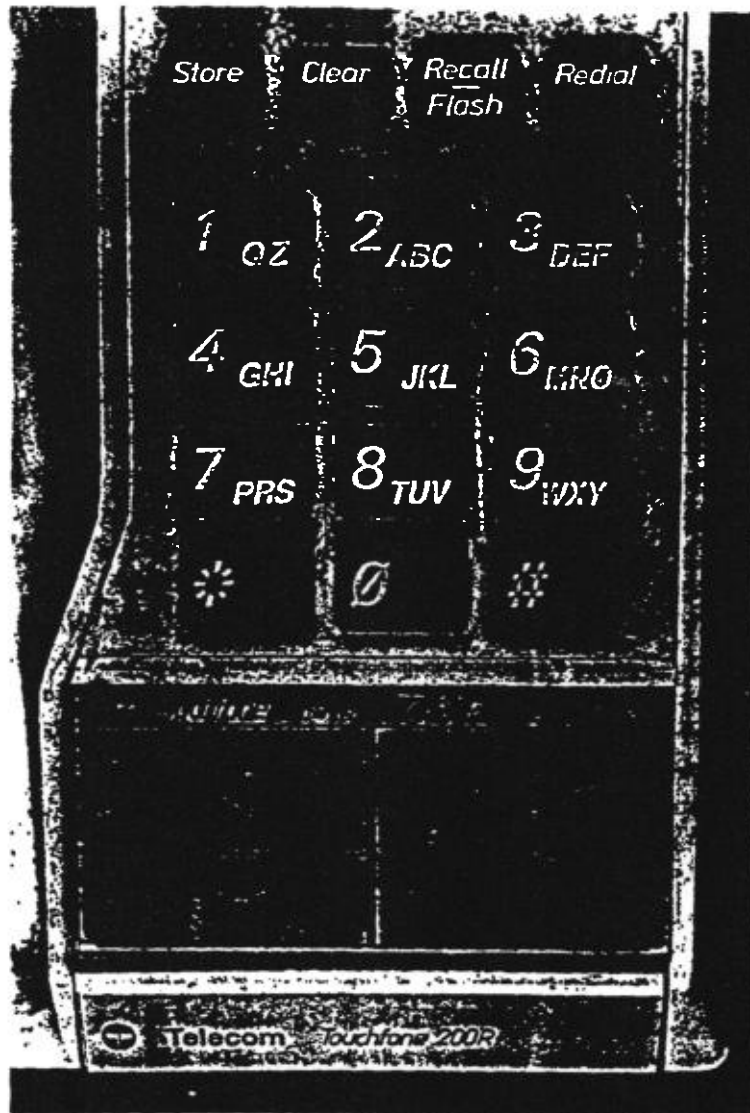
Exhibit AS 4

Photo 3. Close-up of keypad indicating dirty condition and showing customer's number

Keypad Very Dirty ?

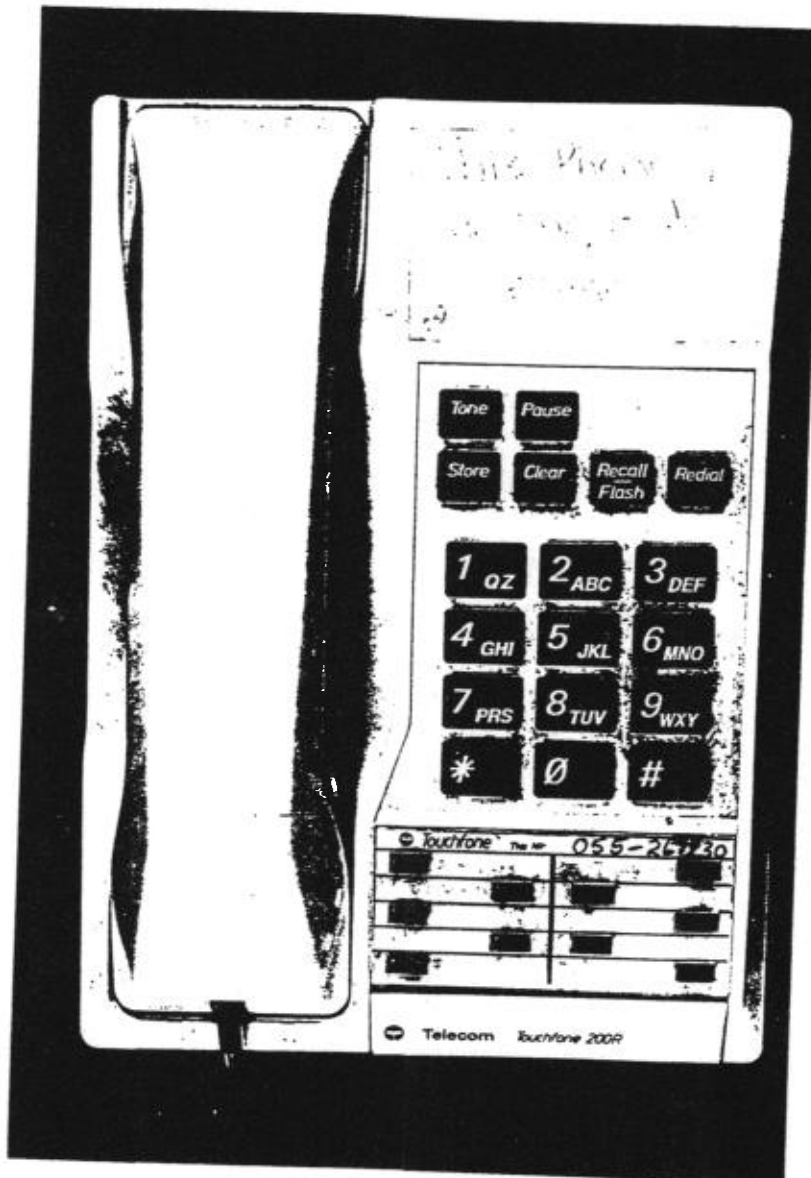
Exhibit AS 5

Photo 1. Front view of COT TF200

Keypad Quiet Clean

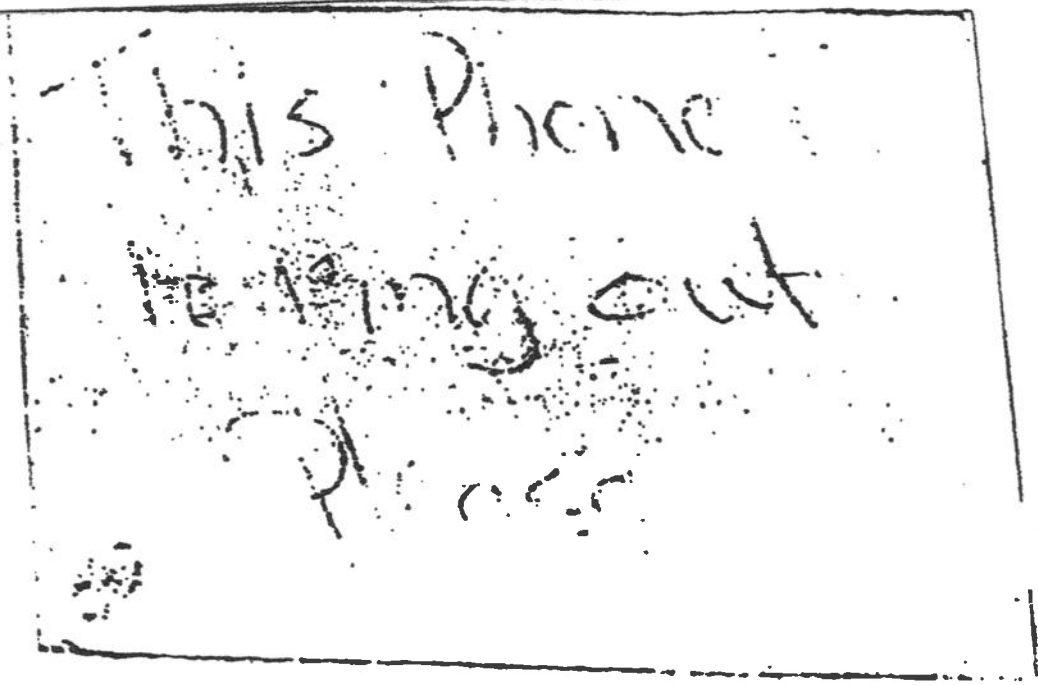
Exhibit AS 6

Photo 5. Close-up of label stuck to case showing

Keypad Quiet Clean
